HERITAGE STATEMENT ST PAUL'S CHURCH, PERTH

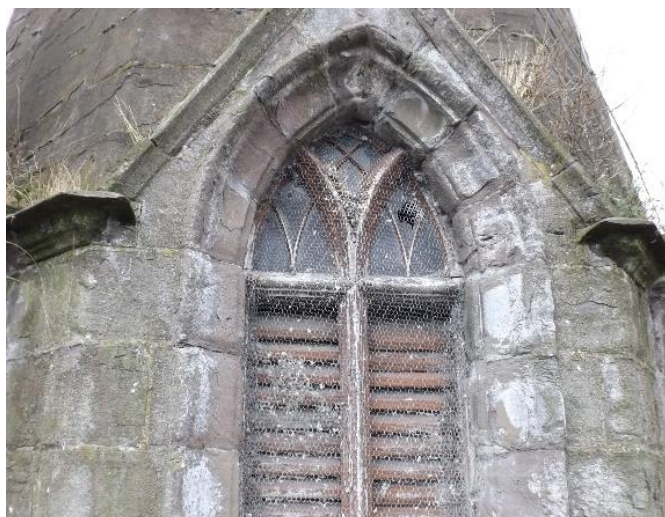
The Spire has suffered the least from deterioration associated with bird ingress and structural issues namely due to the minimal internal finishing. The intention is to retain the tower in an enclosed state maintaining the prominent focal point to the High Street. The top of the spire has been temporarily strapped in recent times as it became apparent the top stone courses were no longer anchored together. The Engineers report proposes this be re-instated with a weathervane installed to the tip of the spire, replicating the historic appearance and securing the structure. The four corner turrets no longer feature their full height pinnacles which are

proposed for reinstatement. Each Turret has its own alcove however no evidence can be found to suggest these ever housed additional ornament. The belfry windows are divided into louvres and an upper leaded glass portion. It is noted the leaded glass does not resemble the remainder of the glazed openings throughout the building, something which is discussed in more detail in the windows section. The louvres are in a poor state of repair however their functionality is still visible, it is therefore intended to repair and

replace louvres as required back to a functional state. Additional bird ingress prevention will be installed internally.

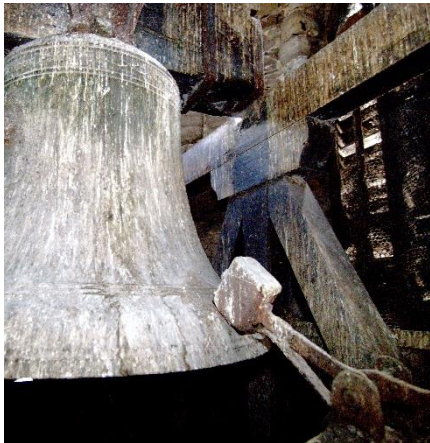
Bell

The bell is located above clock level behind the louvered openings. Although originally installed as a full circle ringing bell, an electronic hammer is currently located adjacent to the bell and is the most recent method of ringing. The bell frame is in a deteriorating condition with the head stock in a cracked state. Proposals are to retain the bell in its current location securing it in a fixed position using a new head stock piece. The lack of a sounding bell has further exacerbated the situation of the building being ignored and overlooked. The reintroduction of an audible beacon on the High Street will reattract attention to the building with the added potential to be used to announce events where previously it would have summoned worshippers.

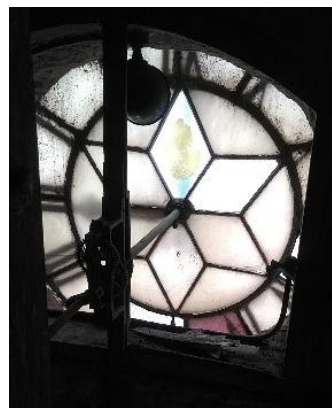
Three clock faces remain in place facing North, West and East. The exterior of the clock faces are iron with leaded white glazing. Behind this the clock mechanism has not functioned for some time however the internal workings appear to still be in place including pendulum and weights. On account of maintenance and capital costs it has been decided a full refurbishment to historically accurate mechanics is not practical or historically necessary. The existing mechanism will be retained on site for accuracy purposes however new electronic controls will be adopted to provide time keeping whilst minimising maintenance and setting requirements.

It is unclear, but assumed that a mock face filled the 4th side of the tower. No mechanical evidence is provided to this façade internally. Externally a rough circular shape is missing from the external face of dressed stone revealing the rubble stone infill. It is proposed to provide a fourth clock for this newly visible location as it will be a major focal point from within the new space..

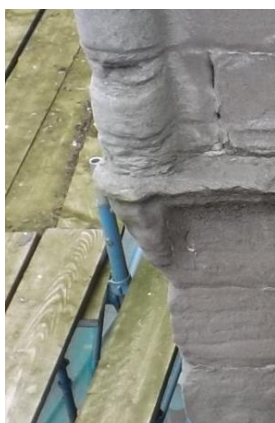
Grotesques, roll-moulded corners and window architraves

There are two known grotesques at St Paul's both of which face North above the first level window height. It is unclear from their current condition if they were highly carved and severely eroded or if they were subtle faces that have suffered an element of erosion. On account of the lack of present day detail at first glance they appear as corner corbels forming part of the corner detail rather than anything more decorative. The lack of any repetition elsewhere on the building further adds to this visual uncertainty. The roll moulded corners, as with elsewhere on the building have suffered varied levels of deterioration and the proposals seek to replace where absolutely required but remove any cementitious material that may be causing accelerated deterioration. This approach, which includes cleaning, will leave visible signs of repair efforts but in an overall managed treatment manner.

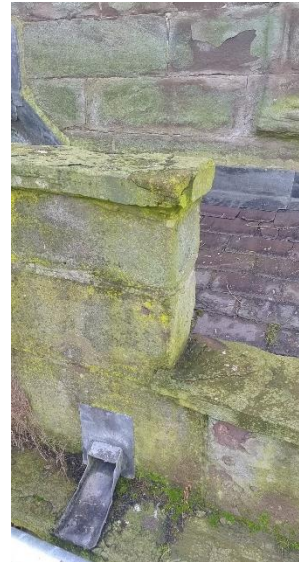
Bartizans and Castellated Parapets

Historic images and on site evidence highlight the height and general geometry the original bartizans and parapet had. Loose sections of parapet have been removed and lost across the main octagon as well as the tower. Each bartizan has been reduced to circa one third its original height. The resulting effect has led to the bartizan remains leaning outward mostly due to the lack of weight above and keying-in effect of coursing with the parapet. The reinstatement of the parapet is the crucial element in reversing the derelict, neglected outlook from which the building has suffered for many years and has formed the key basis throughout all design development. The buttress bartizans that flank the tower on the North Elevation served a double purpose based on site visit and historic images. These bartizans acted as chimney stacks, to the East presumably for the boilers below and to the west for the vestry stove and an unknown additional flue. Where still in evidence these will be retained for interest purposes.

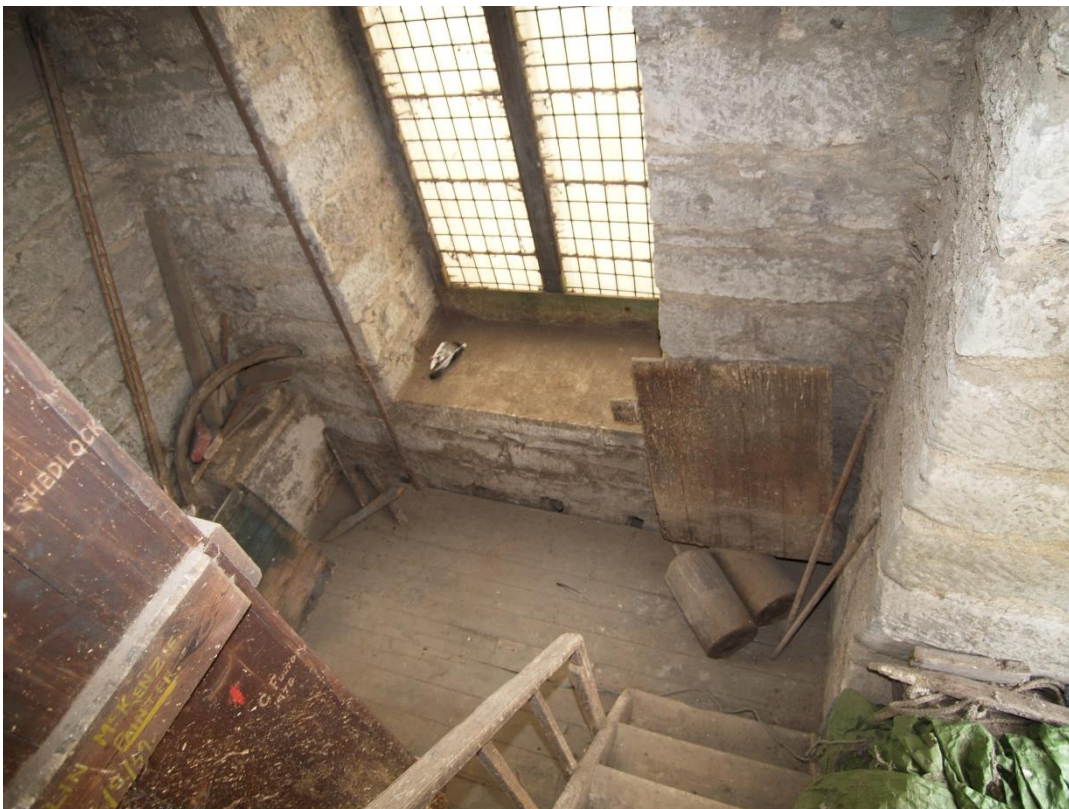
Tower internals

The tower currently has external access via a door to the North. Access from this point is via internal stairs up to the clock mechanism level where a ladder access takes over. The interior of the tower was not as highly finished as the rest of the church. The initial stair case features a barrel vault ceiling, above which lies a small room with a stove, a possible former vestry, although access to this area from the church would have been somewhat contorted. The small room features a leaded glass window to the North in the same style as all other windows. The intention is to repair stair treads and timbers as required however no major intervention is required or intended as access to this area will be controlled and for maintenance purposes only. This approach will ensure the tower is retained in as honest a state as possible for future interpretation.

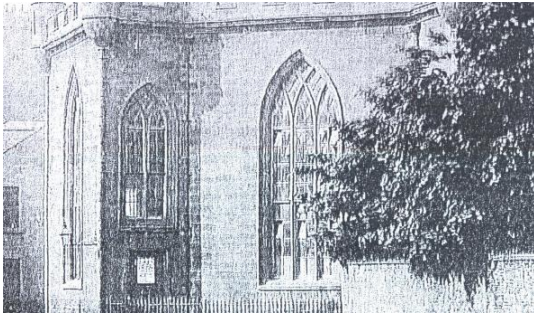
Windows

Existing windows are in a mixture of conditions with in some cases entire casements having fallen inwards. Large areas of leaded glass have been broken and sagging is an issue across most windows. Focusing on the larger buttress windows as main examples it is clear upon close inspection the windows have been altered and adapted from sash and case at some point.

Historic images show large rectangular panes rather than the small square leaded glass currently in place, the heads of each section featured attractive curved glazing bars echoing the stone arches in lightweight timber. In the smallest windows to the sides of the buttresses, the proposals seek to replace the existing leaded glass windows with built up, lime rendered finish infill. The three large windows set back into the buttresses when viewed internally will be stripped of remaining glazing and the surface applied architraves removed to leave the former sash and case frames outlining the curves of the surrounding arches. The timberwork will be repaired with new sills installed and painted to ensure a lasting finish. New internal stone sills are proposed to replace the existing skewed plaster sills. The profile of the new sills will be to match the existing external sill detail merging into the wall reveals either side.

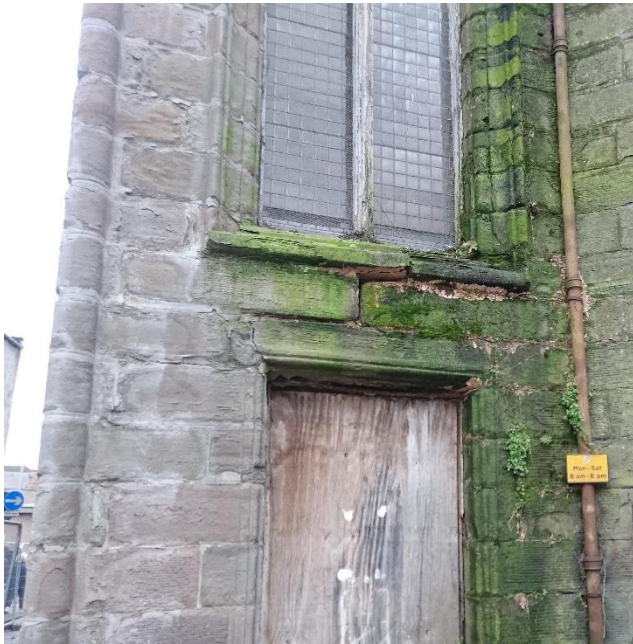
Doors

Existing doors are located at the sides of each buttress in all cases, except the tower buttress, formerly providing access for worshippers into the church with one of each buttress providing access to the balcony stair and main church, the other access to the church only. Access was narrow but plentiful dispersing people to all sides rapidly at the end of services. The proposed use is much more ad hoc and active engagement is more likely via the large openings proposed allowing a clear view of internal activity. The existing buttress door openings are part responsible for the structural defects to the buttress and as part of the structural strategy will be infilled with brick visible internally and lime render externally.

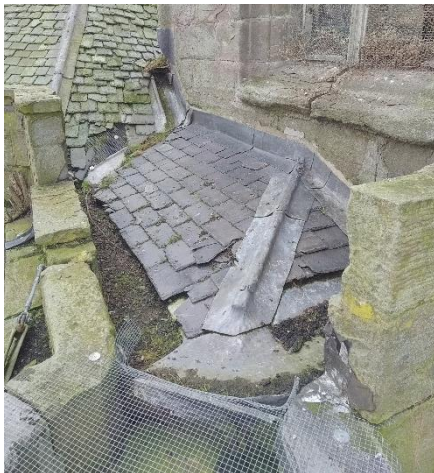
Roof

The existing roof is comprised of eight trapezoidal slate covered faces with small pitched area bridging the valley to the tower and three hipped gables to the buttresses. A flat roof joins the trapezoids together with a central octagonal cupola, the flat roof leadwork has been in a poor state of repair for a number of years including entire sheets detaching from the timber sarking boards beneath. The buttress which abuts the tower has hipped slate gable roofs visible only from parapet level, the Western roof has collapsed.

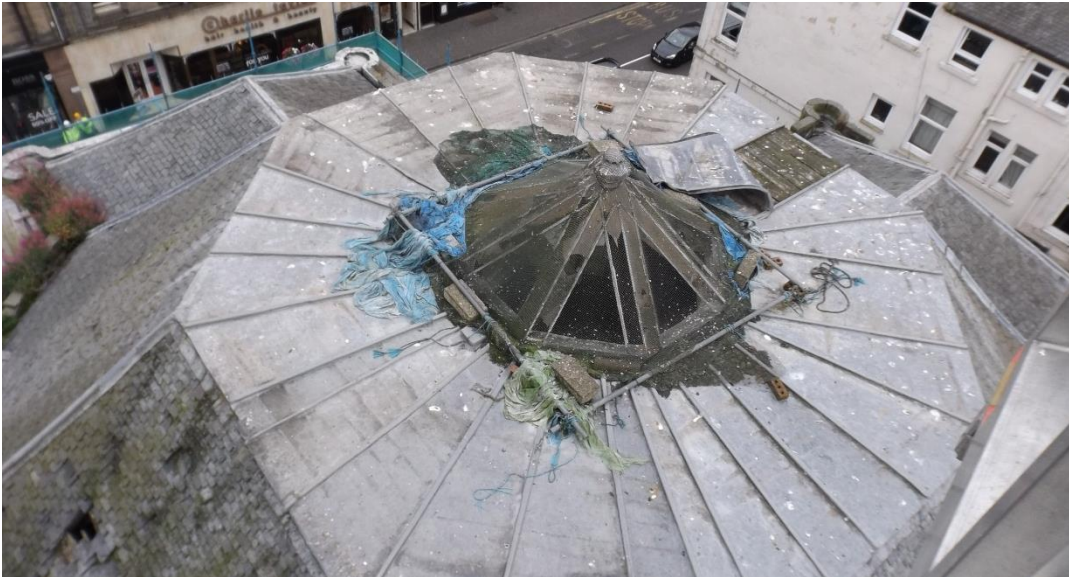
High winds and lack of maintenance has led to the deterioration of the slate roof covering with a large number of non-water tight areas allowing considerable rainwater and daylight into the main space. Extensive investigation has determined that the roof is capable of repair, however, this would result in a large percentage of new structure and would require the complete stripping of the interior lath and plaster finish for guano clearing and general safety. The difficult decision has been taken to propose the removal of the entire roof structure creating an external entertainment space for events and general day to day use, a use which will engage people with the building once again and potentially spark investment interest to later reinstate the roof and create a building once again. The removal of the roof over the main space and three buttresses will create an entirely open external space, the fourth buttress requires an alternative treatment as it abuts the tower over spaces intended to remain internal. Flat roof infills are proposed providing greater definition to the tower as it emerges from the main structure and respecting the lack of visibility these areas of roof have always received.

From a structural perspective, the removal of the roof requires a counter approach to hold the wall heads in place and prevent collapse. A ring beam has therefore been proposed and incorporated within the new wall head detail. Internally a new face of dressed stone to match existing will replace areas of damaged stone and conceal the new concrete ring beam. The new stone will be read as a clear alteration defining the intervention. Existing timber safe lintels require to be replaced above each window opening with proposed concrete lintels. The decision has been made to expose the underside of these lintels finishing them with dark grey paint. A concealed bracket will be fixed to the face of the lintels allowing the installation of a stone veneer to match the existing finish. The new lintel and ring beam will be announced visibly via the use of new stone and has been designed to allow full future reversibility of the roof structure whilst remaining in situ.

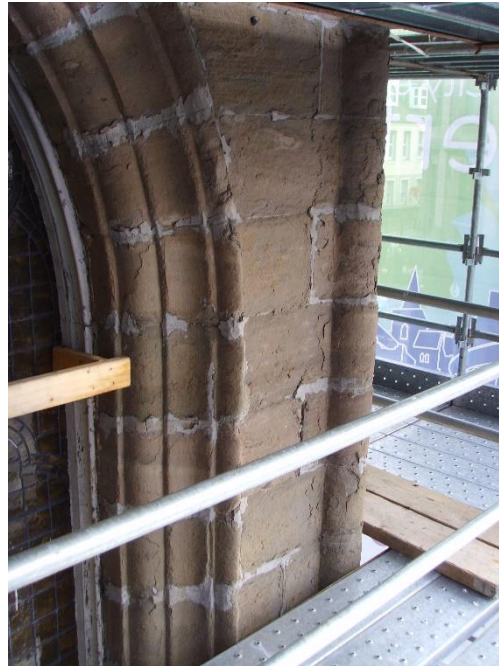
Stonework and Mortar

The existing sandstone has suffered from erosion, organic growth and poor mortar choices. Large quantities of cementitious mortar have been used across the building resulting in dramatic damage to decorative and coursed stonework. It is proposed to investigate the existing lime mortar build up and seek advice on existing and suggested proposed mortar specification via the Scottish Lime Centre.

As part of a building wide stone survey all lintels, architraves and stone lintel and door surrounds were assessed for integrity and visual deterioration. Where possible items are not proposed for major intervention with many only requiring revised mortar and cleaning. There are examples of cracked door lintels which could be pinned to an engineering satisfaction however from an aesthetic perspective and honesty to purpose it was felt new lintels in these instances would be more in keeping.

The weathering and cement damage effect to the stone has eroded the drove work finish and despite still having clear coursing has created a more rustic effect to the building. Internally it is not proposed to replicate the droved finish on any new stone with the exception of the piers at the new entrances. Externally it was decided that to try and replicate the droving across the building would be inappropriate

All stone and timber produced from the down takings will be assessed carefully for use as salvage within the repairs and reinstatement works. Insufficient stone quantities will be generated by the salvage, therefore new stone will be required, chosen based on information provided within a report on Building Stone Assessment prepared by the British Geological Survey in April 2017. The report highlights suggested quarries which may be able to provide geologically similar stone. The report analyses colour, stone fabric, granular sizing permeability, etc. Permeability will be a crucial consideration in such exposed locations to allow the lime mortars to perform effectively.
