HERITAGE STATEMENT ST PAUL'S CHURCH, PERTH

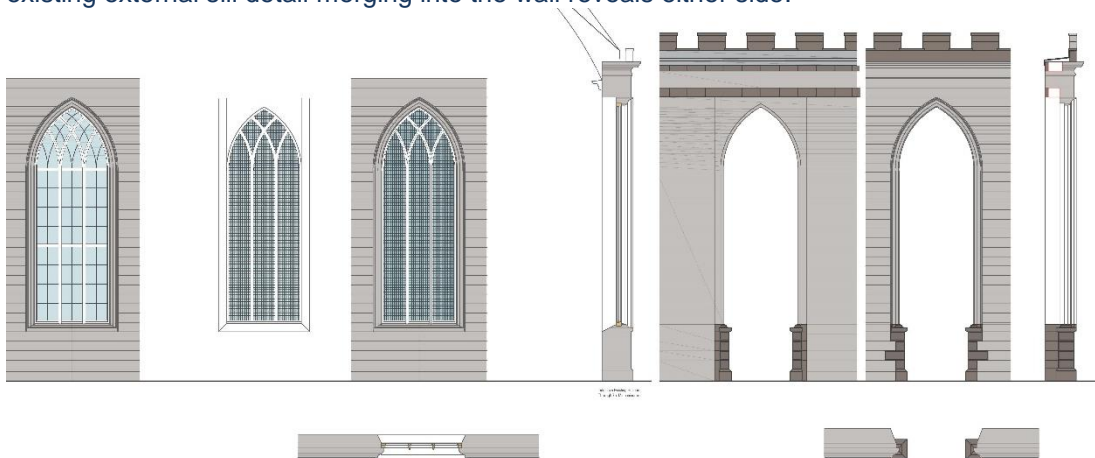
Existing windows are in a mixture of conditions with in some cases entire casements having fallen inwards. Large areas of leaded glass have been broken and sagging is an issue across most windows. Focusing on the larger buttress windows as main examples it is clear upon close inspection the windows have been altered and adapted from sash and case at some point.

Historic images show large rectangular panes rather than the small square leaded glass currently in place, the heads of each section featured attractive curved glazing bars echoing the stone arches in lightweight timber. In the smallest windows to the sides of the buttresses, the proposals seek to replace the existing leaded glass windows with built up, lime rendered finish infill. The three large windows set back into the buttresses when viewed internally will be stripped of remaining glazing and the surface applied architraves removed to leave the former sash and case frames outlining the curves of the surrounding arches. The timberwork will be repaired with new sills installed and painted to ensure a lasting finish. New internal stone sills are proposed to replace the existing skewed plaster sills. The profile of the new sills will be to match the existing external sill detail merging into the wall reveals either side.

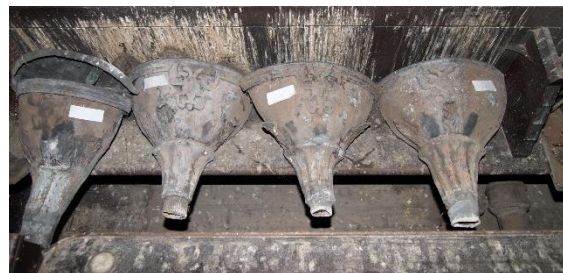
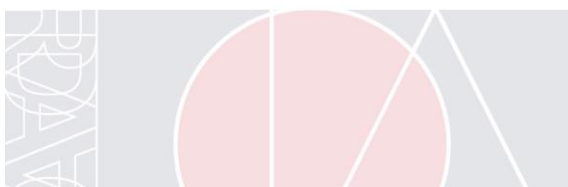
Lead hoppers have been salvaged from the site and are in storage however have suffered greatly from mal treatment and are not in a suitable condition to be reinstated. The removal of the roof removes their need, along with the existing downpipes and it is not proposed to reinstate these as a folly.

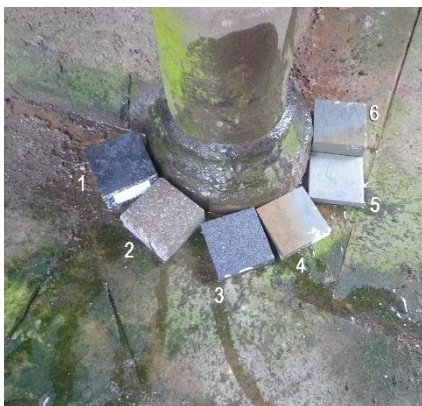
The weathering and cement damage effect to the stone has eroded the drove work finish and despite still having clear coursing has created a more rustic effect to the building. Internally it is not proposed to replicate the droved finish on any new stone with the exception of the piers at the new entrances. Externally it was decided that to try and replicate the droving across the building would be inappropriate

All stone and timber produced from the down takings will be assessed carefully for use as salvage within the repairs and reinstatement works. Insufficient stone quantities will be generated by the salvage, therefore new stone will be required, chosen based on information provided within a report on Building Stone Assessment prepared by the British Geological Survey in April 2017. The report highlights suggested quarries which may be able to provide geologically similar stone. The report analyses colour, stone fabric, granular sizing permeability, etc. Permeability will be a crucial consideration in such exposed locations to allow the lime mortars to perform effectively.
